LOWER CONNECTICUT RIVER BASIN
EAST HADDAM , CONNECTICUT

BASHAN LAKE DAM
CT 00354

PHASE I INSPECTION REPORT
NATIONAL DAM INSPECTION PROGRAM

FEBRUARY 1979

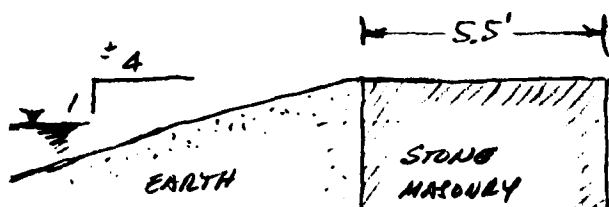
PRESENTLY THE SPILLWAY IS OBSTRUCTED BY WOOD PLANKS SERVING AS A BRIDGE SPANNING THE SPILLWAY OVER 2 RECTANGULAR CONCRETE BLOCKS (PIERS) 1.2' AND 2.2' WIDE, RESPECTIVELY, AND A

5' (\pm) CHAIN LINK FENCE.

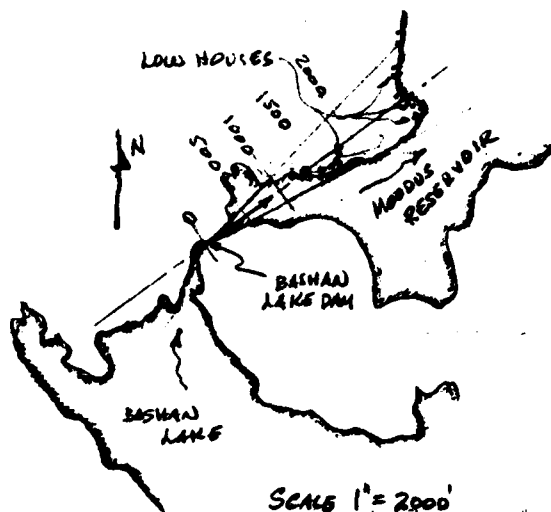
A (±) 10' HIGH FLOOD WAVE (INSTANTANEOUS $Q = 3000 \text{ CFS}$) GENERATED UPON FAILURE OF BASHAN LAKE DAM, WOULD ENTER MOODUS LAKE AND MOVE ACROSS THE RESERVOIR TO THE OPPOSITE SHORE (±) 1500' D/S FROM THE DAM. (SEE SKETCH)
